OFFICE OF THE  
DOUGLAS COUNTY SURVEYOR

0-029

Station: OLA-8 T 29 S, R 7W, Sec 5

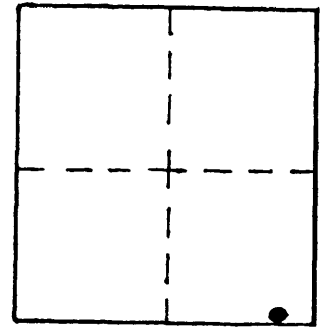
A 3 INCH DIAMETER DCSO DISK STAMPED "OLA-8 1999"  
SET FLUSH IN TOP OF 8 INCH DIAMETER CONCRETE FILLED, 40 INCH  
LONG PVC PIPE SEGMENT, FIRMLY SET AND PROTRUDING  
APPROXIMATELY 9 INCHES ABOVE GROUND.

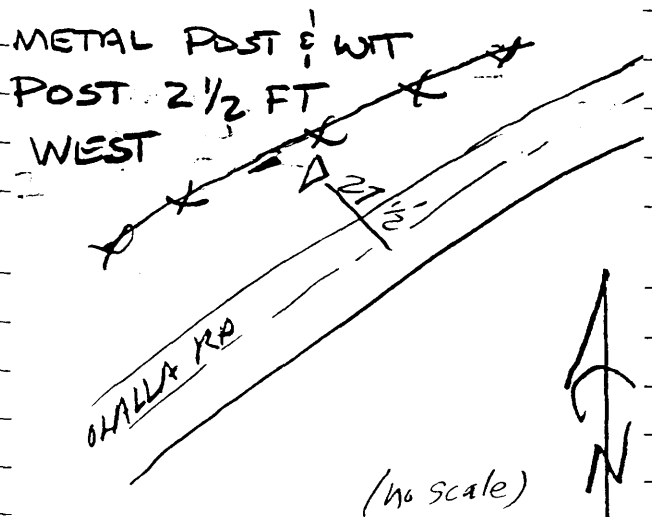
Reference Marks:

FROM THE INTERSECTION HOOVER HILL ROAD (CO. RD. #125)  
AND OLALLA ROAD (CO. RD. #38) IN T28S, R7W, SEC 34  
PROCEED SOUTHWESTERLY ALONG OLALLA ROAD APPROXIMATELY  
2<sup>o</sup> MILES TO MONUMENT ON RIGHT.
